# **PHASE I ENVIRONMENTAL SITE ASSESSMENT REPORT**

**UNION COUNTY  
VACANT COUNTY PARCEL  
SWC SW 1<sup>ST</sup> STREET AND SW 1<sup>ST</sup> AVENUE  
LAKE BUTLER, FLORIDA  
ACRES NO. 257971**

**PPM PROJECT NO. 20165101-TASK 13**

**DECEMBER 11, 2023**

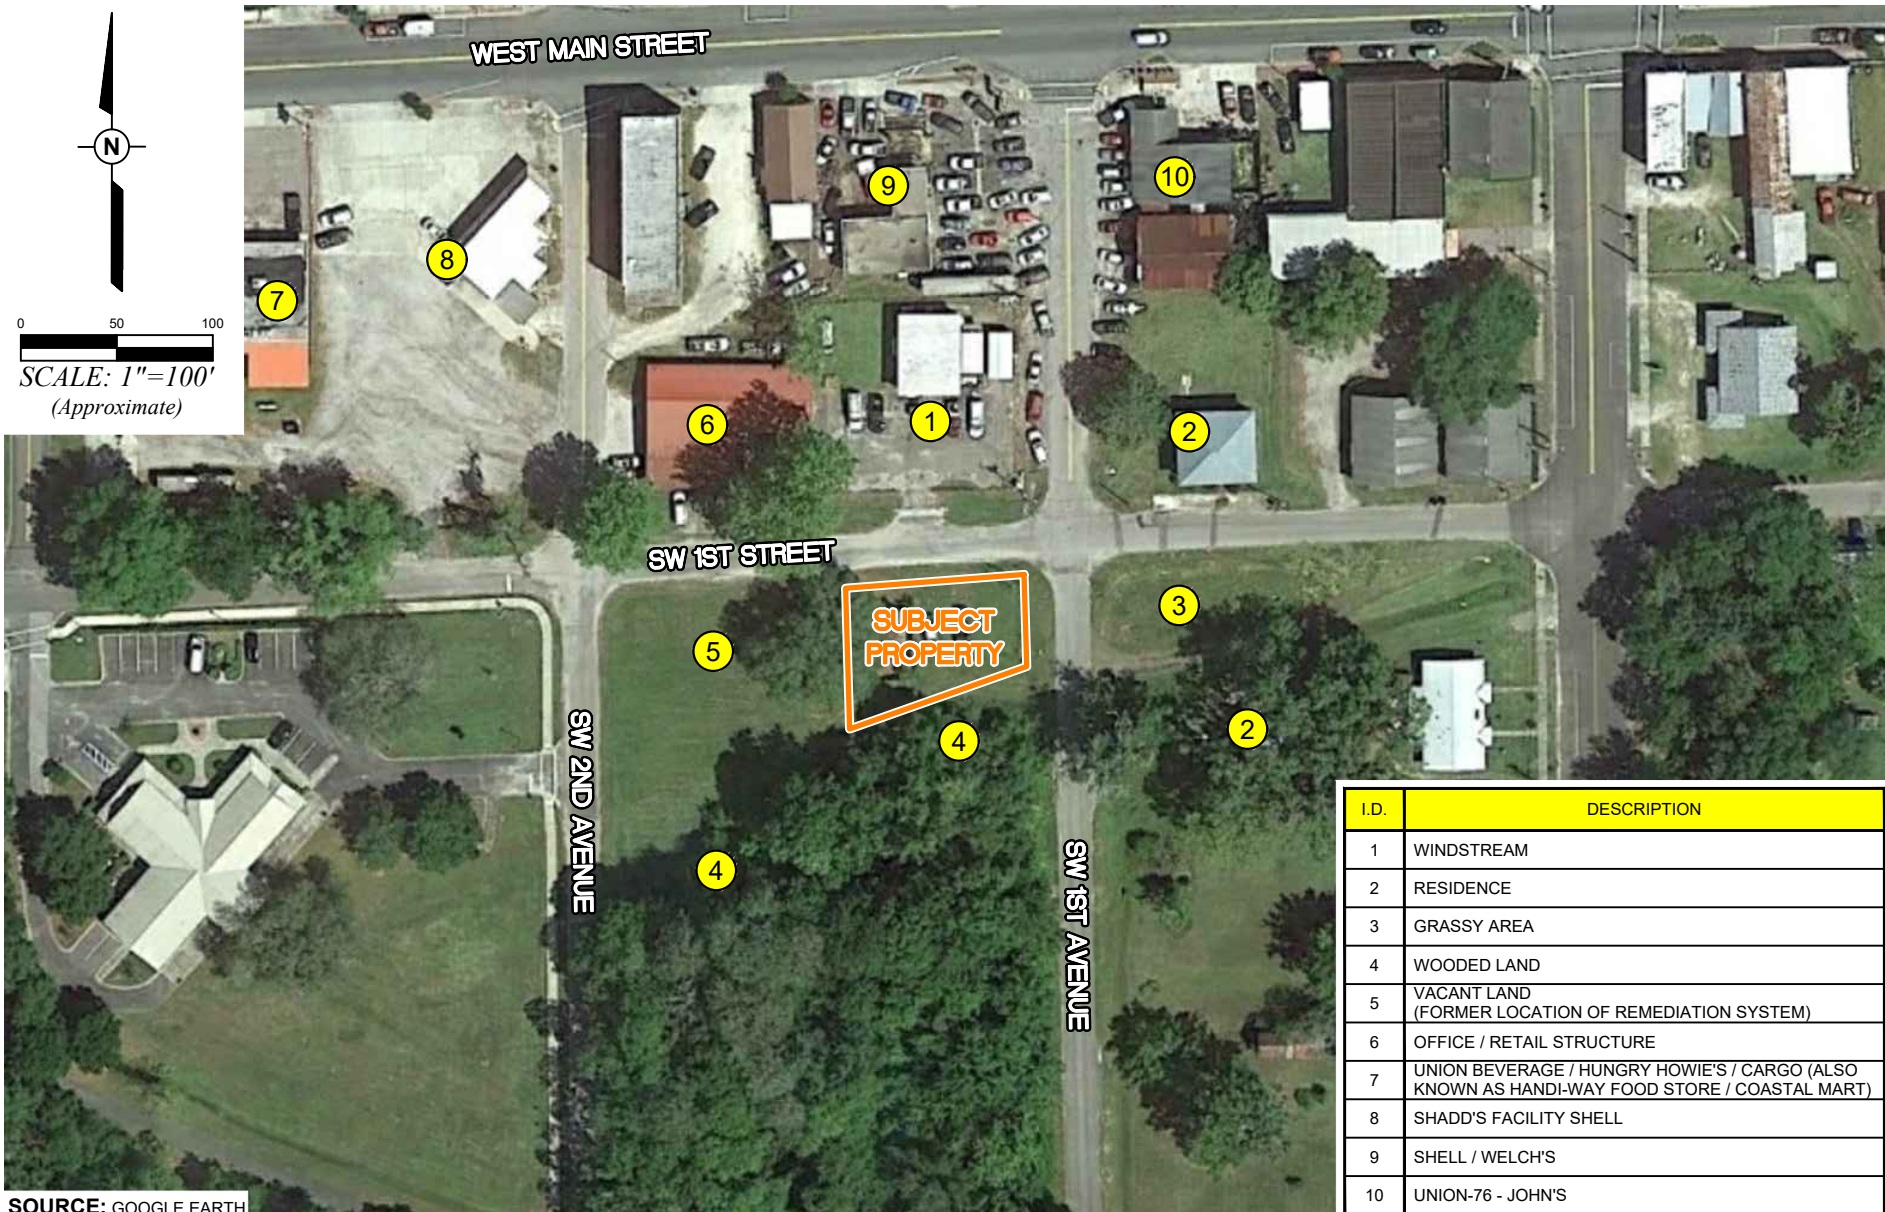
I.D.	DESCRIPTION
1	WINDSTREAM
2	RESIDENCE
3	GRASSY AREA
4	WOODED LAND
5	VACANT LAND (FORMER LOCATION OF REMEDIATION SYSTEM)
6	OFFICE / RETAIL STRUCTURE
7	UNION BEVERAGE / HUNGRY HOWIE'S / CARGO (ALSO KNOWN AS HANDI-WAY FOOD STORE / COASTAL MART)
8	SHADD'S FACILITY SHELL
9	SHELL / WELCH'S
10	UNION-76 - JOHN'S

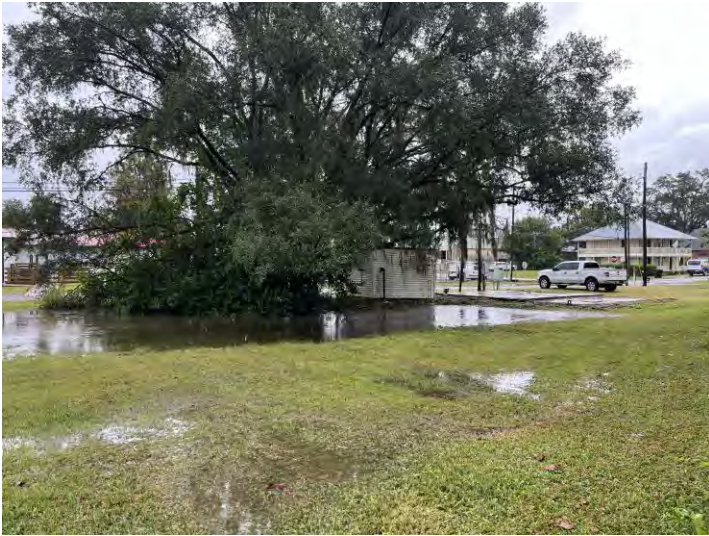
PHOTOGRAPH 1

View of the west portion of the subject property, facing northeast.

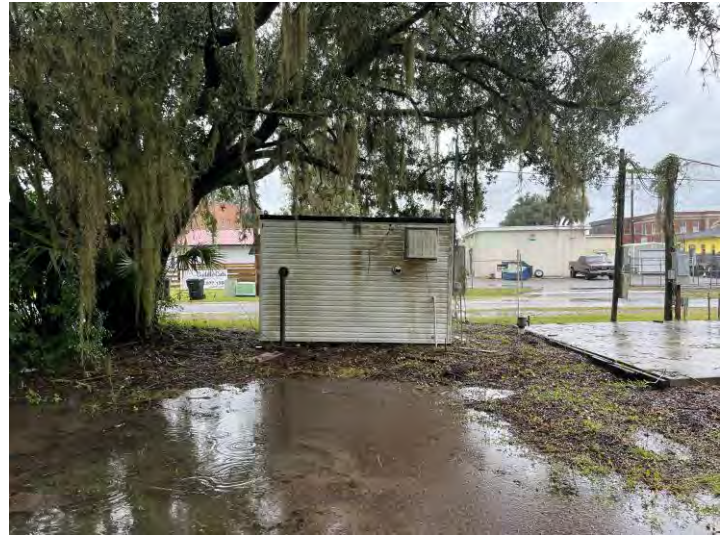
PHOTOGRAPH 2

View of the south side of a remediation system shed on the west portion of the subject property, facing north.

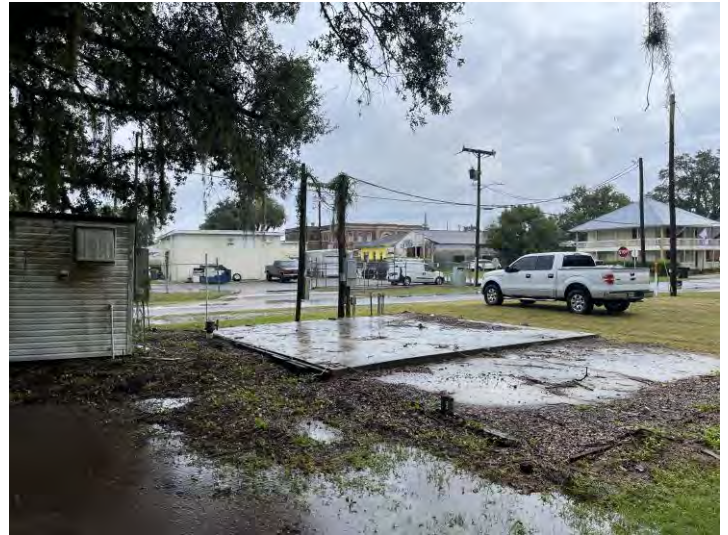
PHOTOGRAPH 4

View of a concrete pad from a former remediation system on the subject property, facing northeast.

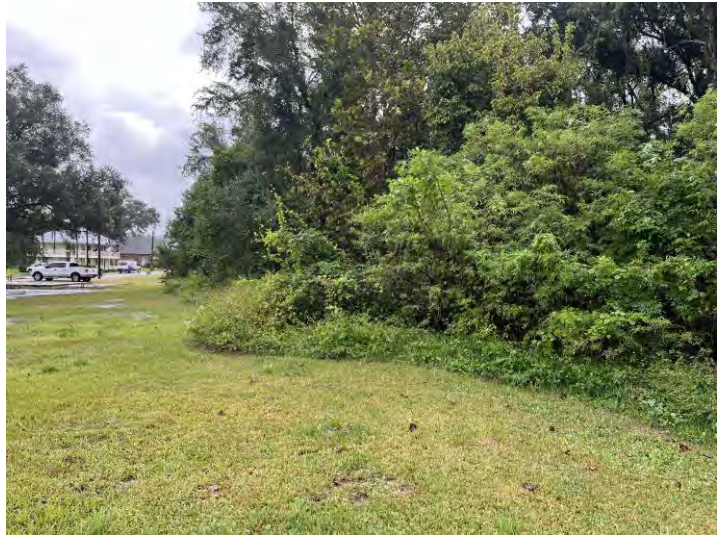
PHOTOGRAPH 6

View of the south portion of the subject property, facing east-northeast.

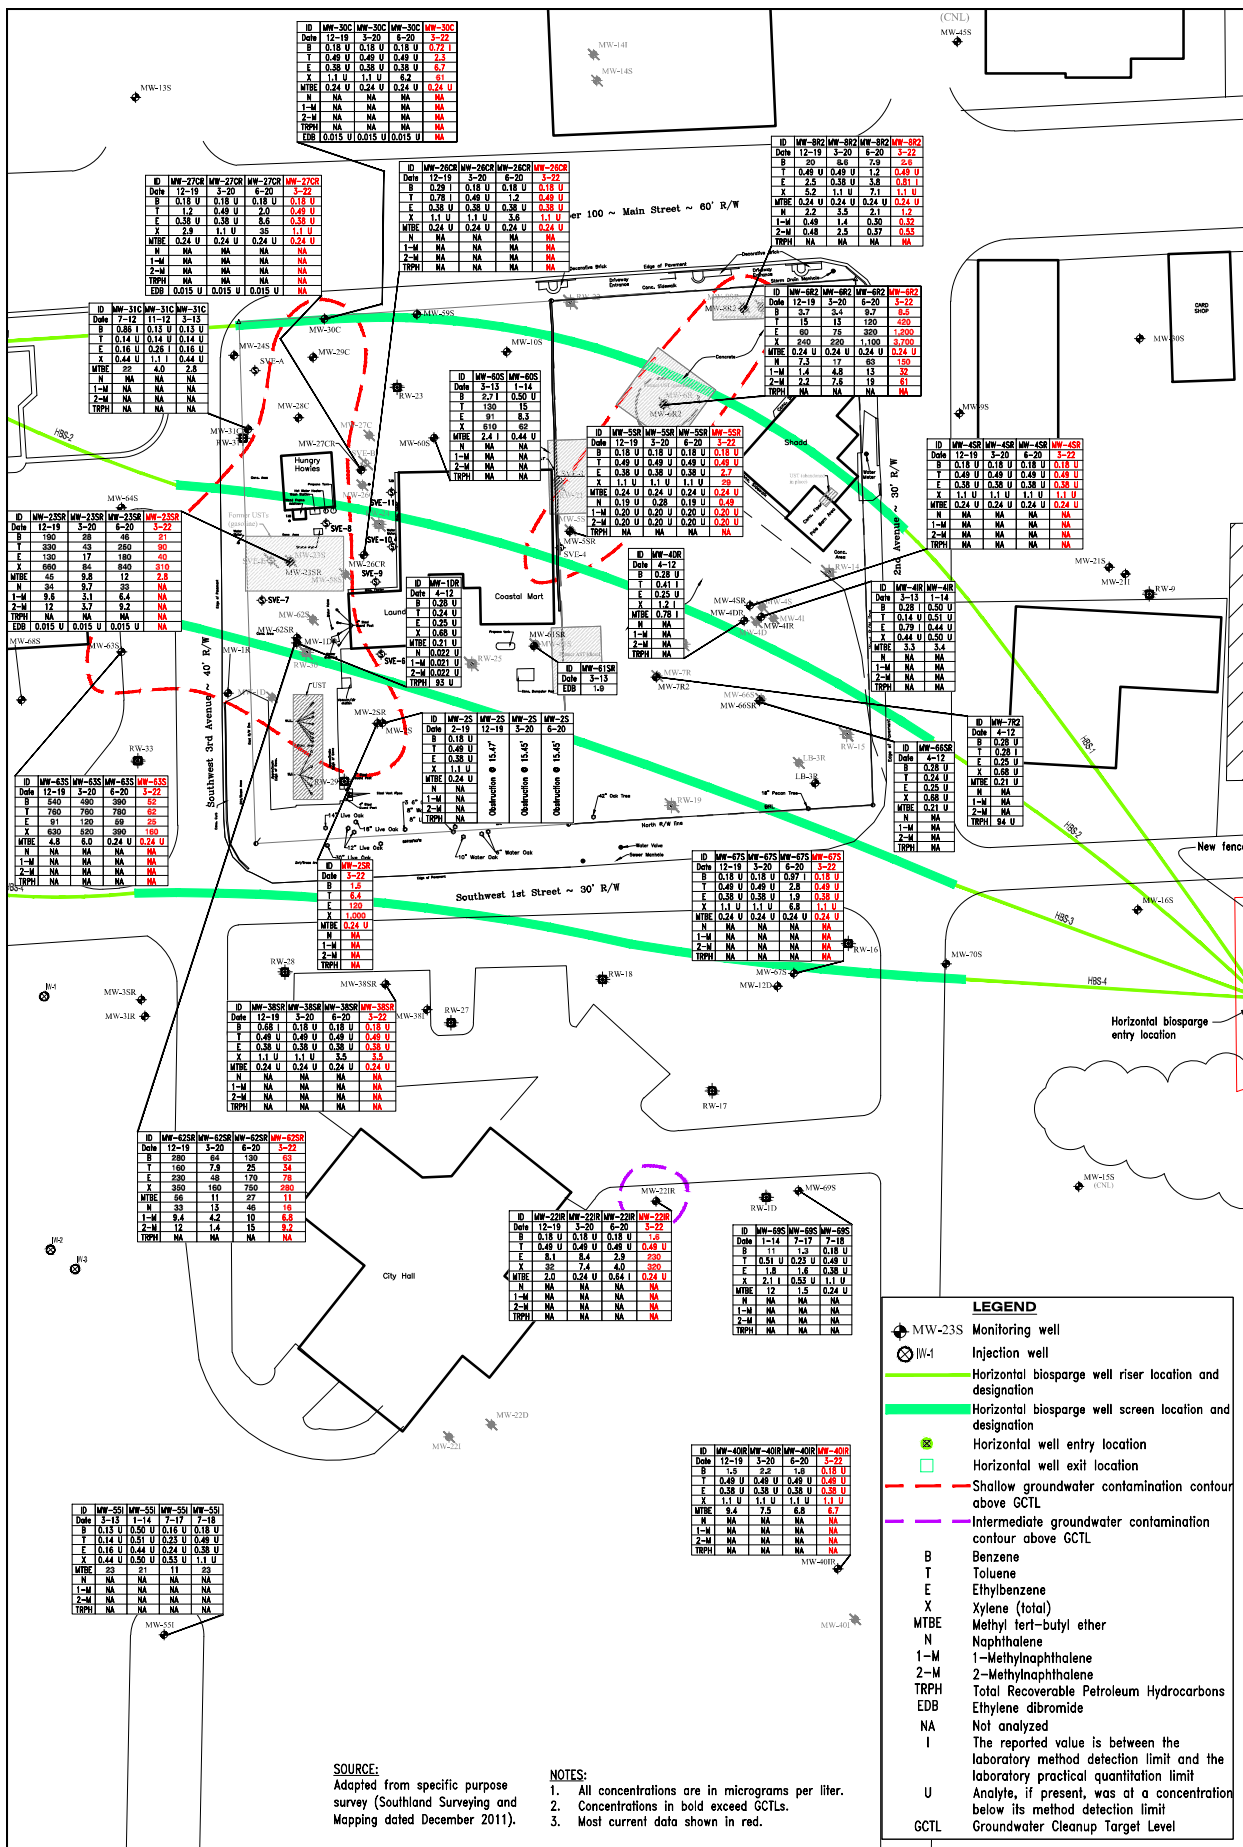
GROUNDWATER ANALYTICAL DATA			
NO.	DATE	REVISIONS	FIGURE:
0	Apr-22	Initial Submittal	4
DESIGNED	DRAWN	CHECKED	DATE
AH	CB

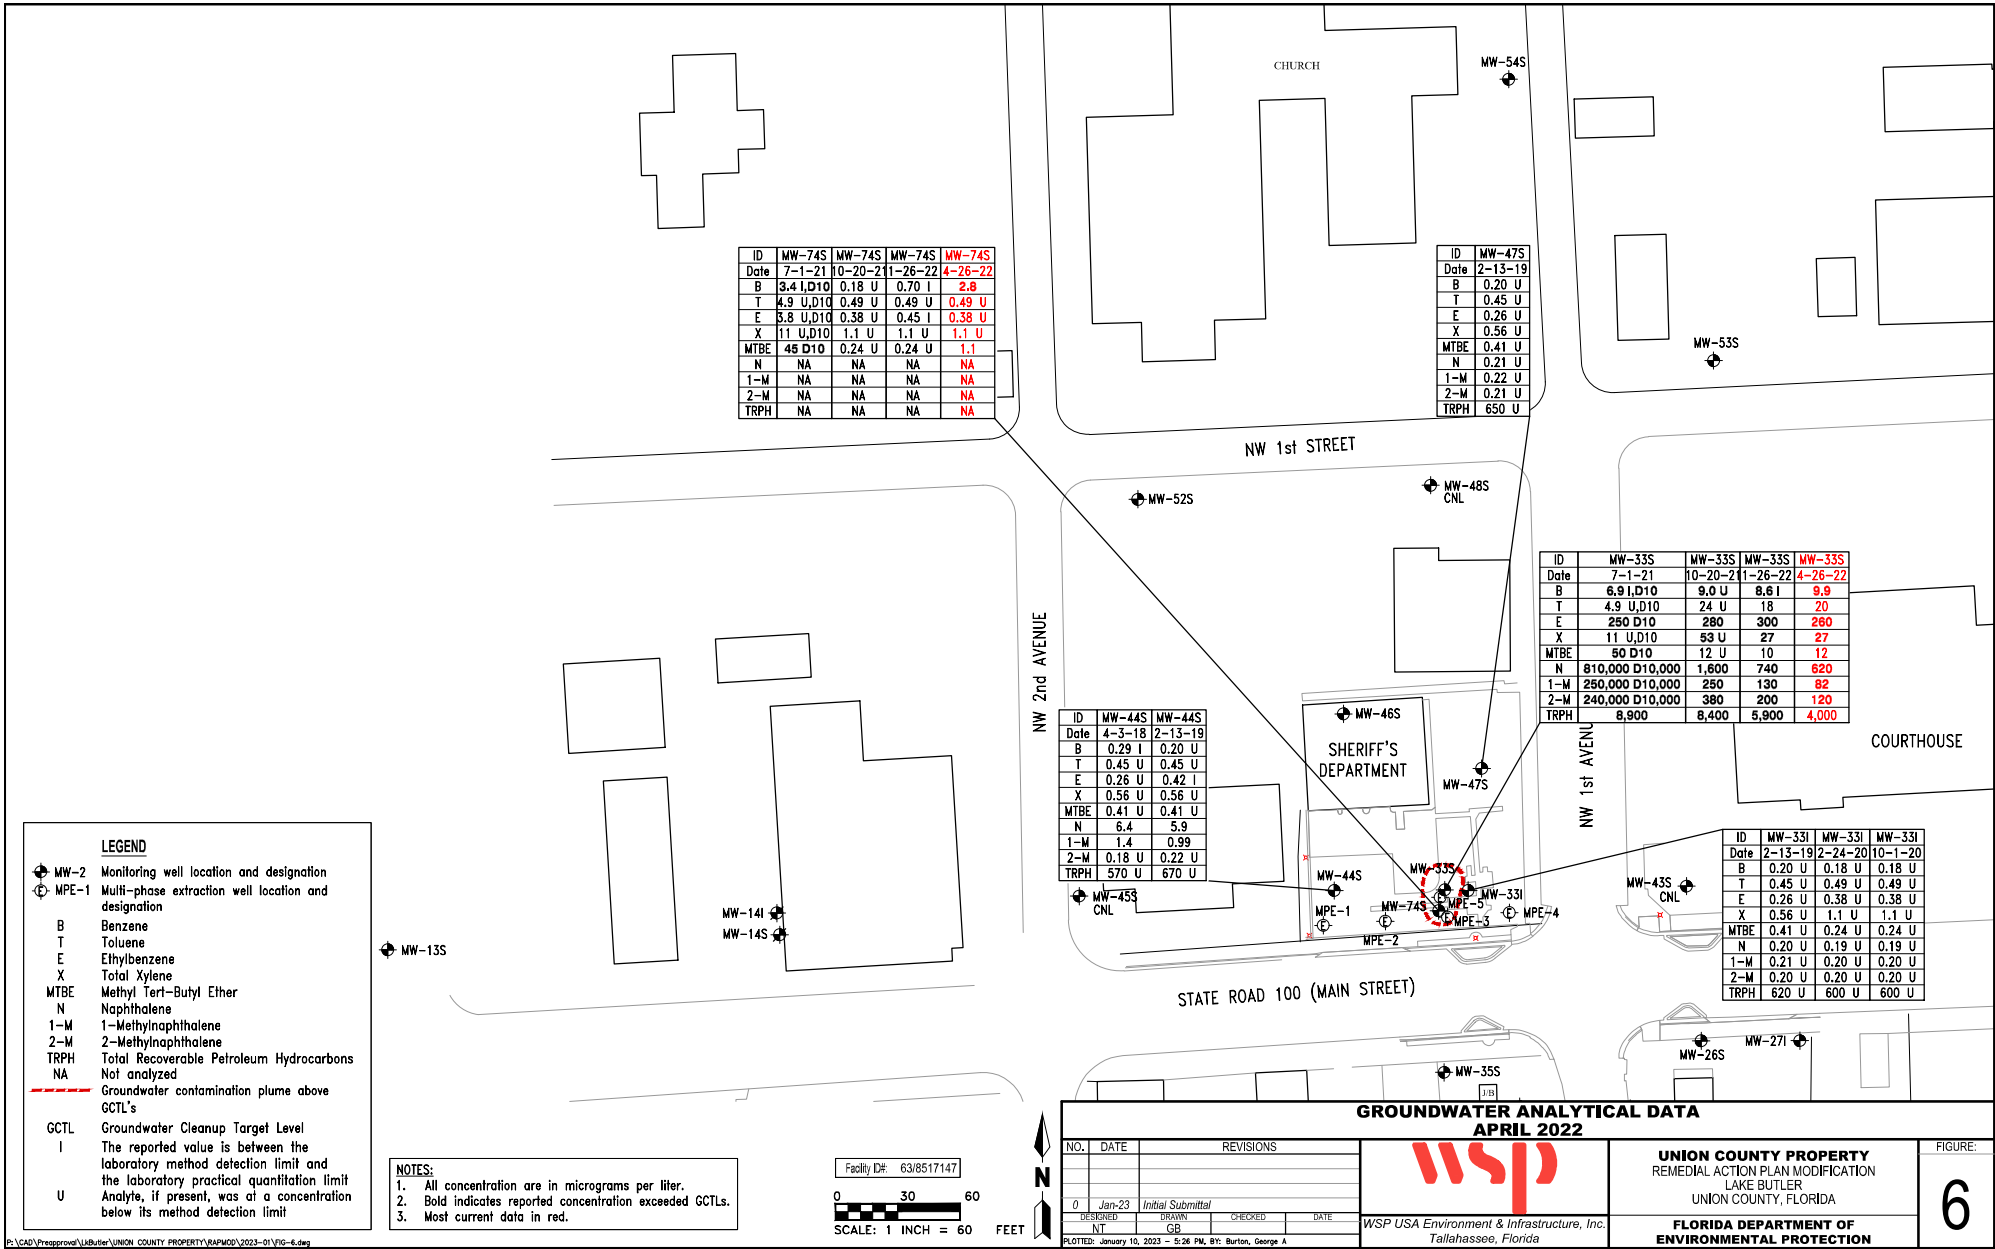
GROUNDWATER ANALYTICAL DATA				APRIL 2022		UNION COUNTY PROPERTY		FIGURE:
NO.	DATE	REVISIONS		REMEDIAL ACTION PLAN MODIFICATION		LAKE BUTLER		6
0	Jan-23	Initial Submittal		UNION COUNTY, FLORIDA		FLORIDA DEPARTMENT OF ENVIRONMENTAL PROTECTION		
DESIGNED	DRAWN	CHECKED	DATE	WSP USA Environment & Infrastructure, Inc.		Tallahassee, Florida		
PLOTED: January 10, 2023 - 5:26 PM, BY: Burton, George A

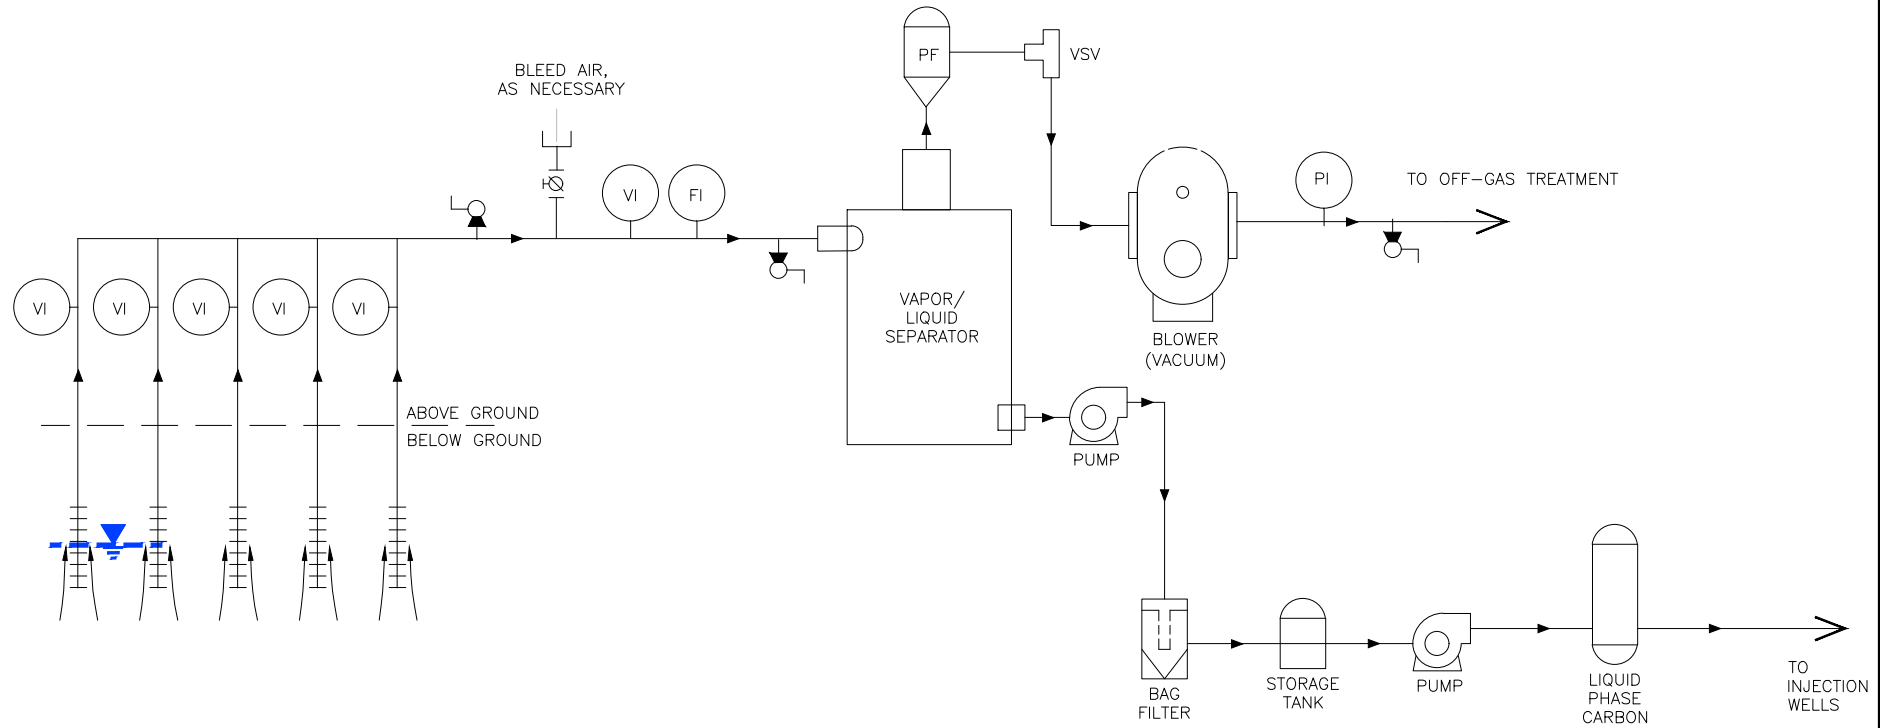
GENERIC VACUUM EXTRACTION SCHEMATIC  
(NOT TO SCALE)
