PHASE I ENVIRONMENTAL SITE ASSESSMENT REPORT

**UNION COUNTY
WEST MAIN STREET PROPERTY
102/120 WEST MAIN STREET
LAKE BUTLER, FLORIDA
ACRES NO. 250833**

PPM PROJECT NO. 20165101.TASK 11

DECEMBER 12, 2023

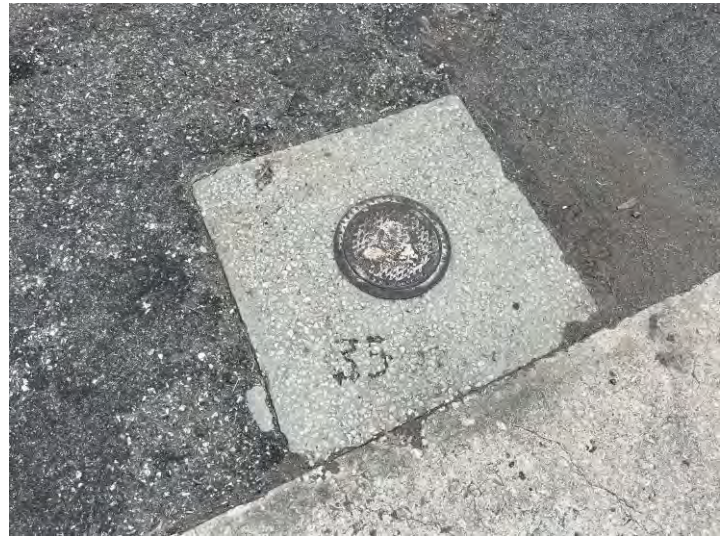
PHOTOGRAPH 6
View of one of the groundwater monitoring wells (MW-35) on the subject property.

Wells: PPM observed the presence of four groundwater monitoring wells (MW-34S, MW-35S, MW-36S, and MW-37S) and one recovery well (RW-7) on the subject property. The wells are associated with assessment activities conducted for a petroleum contamination plume in the surrounding area, including the subject property. PPM obtained previous groundwater sampling results for the wells. The most recent results found for MW-34S, MW-35S, MW-36S, and MW-37S were dated 2005, 2017, 2009, and 2008, respectively. MW-34S was sampled for BTEX, MTBE, naphthalene, 1-methylnaphthalene, 2-methylnaphthalene, acenaphthene, acenaphthylene, and fluorene. MW-35S was sampled for BTEX, MTBE, naphthalene, 1-methylnaphthalene, 2-methylnaphthalene, and TRPH. MW-36S and MW-37S were both sampled for BTEX and MTBE. The analytical results for MW-34S, MW-36S, and MW-37S were all below detection limits and the results for MW-35S were all below their respective GCTLs.

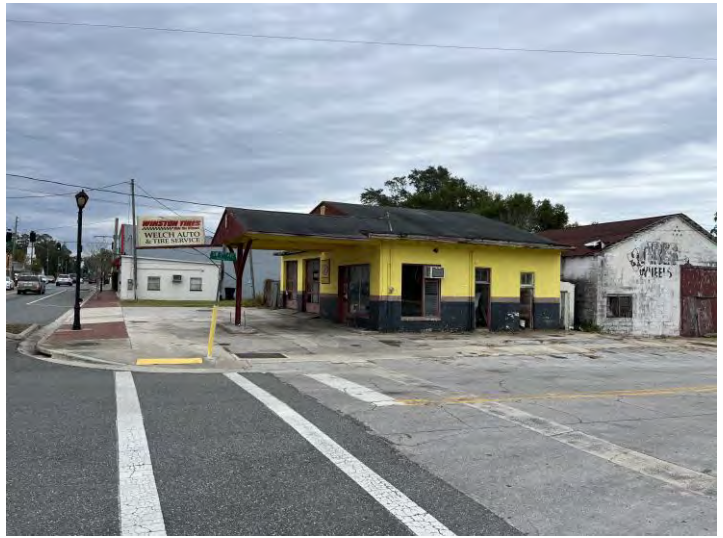
PHOTOGRAPH 10

View of a vacant automobile repair facility and former retail petroleum station on the adjoining property to the east, across SW 1st Avenue, facing east-southeast.

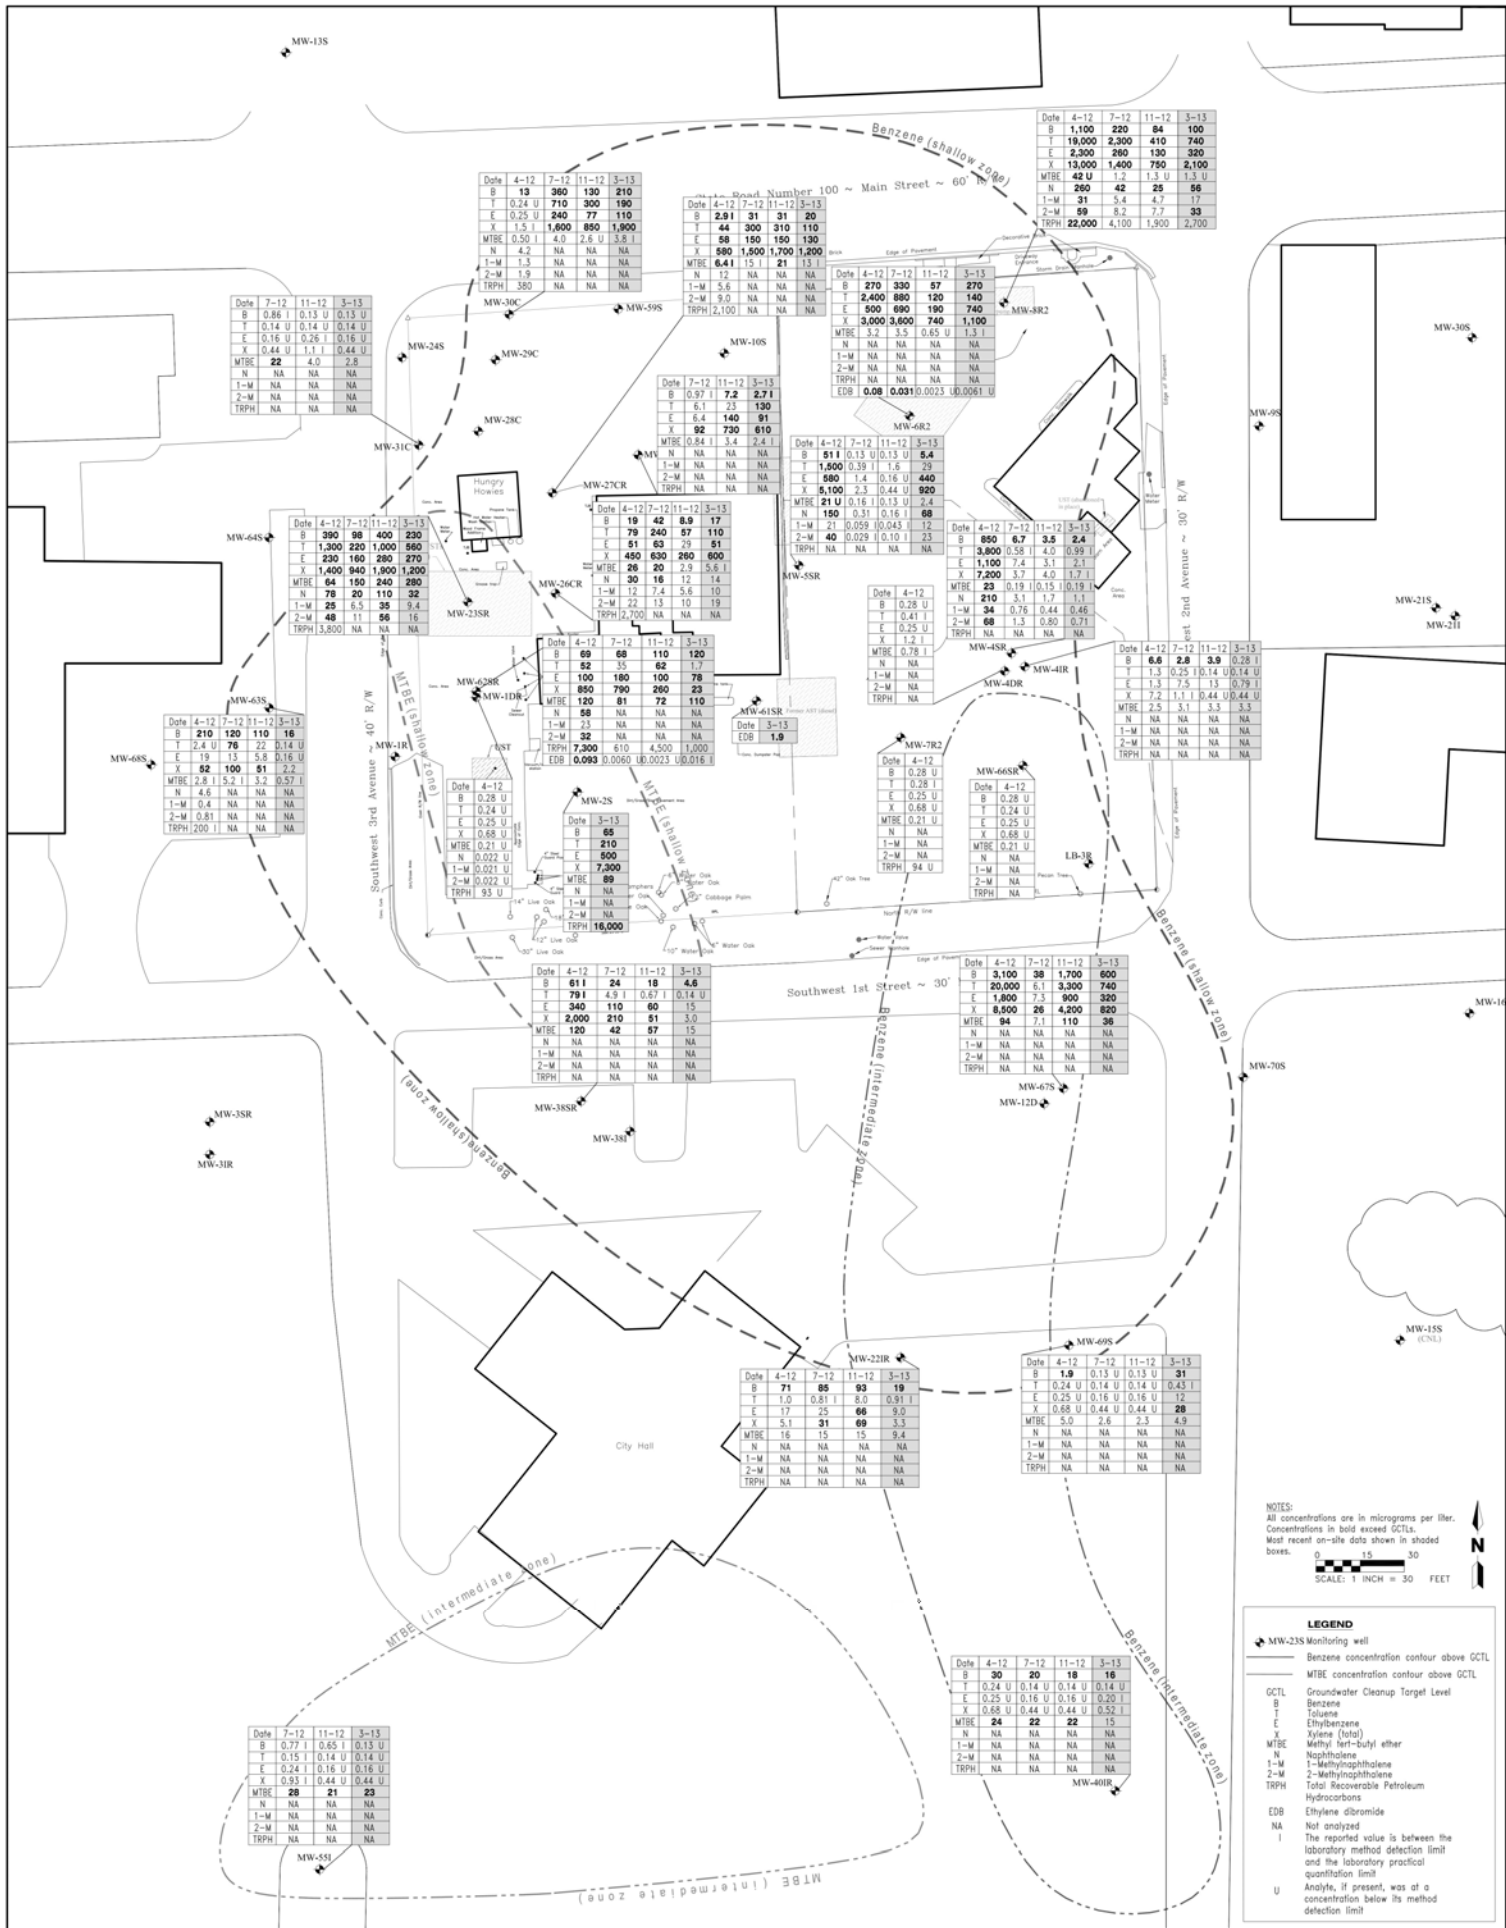
FIGURE: 9

Date	4-12	7-12	11-12	3-13
B	0.86	0.13	0.13	U
T	0.14	0.14	0.14	U
E	0.16	0.26	0.16	U
X	0.44	1.1	0.44	U
MTBE	22	4.0	2.8	U
N	NA	NA	NA	NA
1-M	NA	NA	NA	NA
2-M	NA	NA	NA	NA
TRPH	NA	NA	NA	NA
